#### FEDERATION FRANCAISE DES PILOTES MARITIMES

NOTE D'INFORMATION – 2010-04 du 02-04-2010

#### LES ECHELLES DE PILOTE

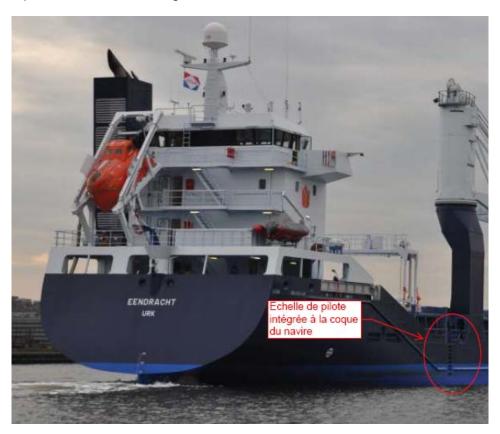
#### B- Exemple d'une défectuosité

L'illustration ci-dessous est relative à une inscription qui a eu lieu dans la base de donnée de la FFPM il y quelques semaines suite à une escale dans un port français.

En pareil cas nous ne pouvons que vous inciter à exiger l'installation d'un dispositif d'embarquement conforme à la règlementation SOLAS.

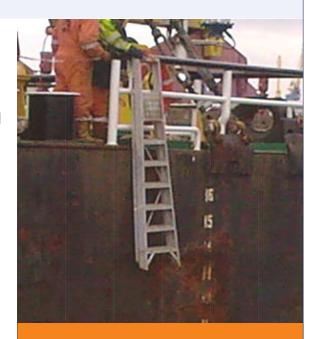
▲ This is not a pilot ladder

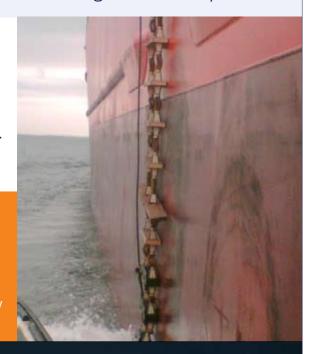
➤ Well positioned, well maintained and properly rigged ladder.

Within parallel length, mid ships and steps resting firmly against ships side.
